# Manhole Inspection Summary

Manhole # S37C\_\_009MH

**Inspection** ☐ Is Incomplete Rating: **3) Fair**

**Location** Address: **808 groome al**

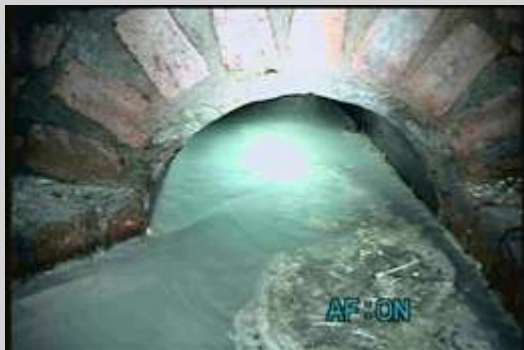
12 O'Clock Outflow

12 in. Circular Gravity Sewer  
Pipe Out @ 12 O'Clock

Pipe Material: **Clay** ☐ Pipe Lined

Invert Depth: **13.20** (ft.) Flow Characteristics: **Slow**

Deposits: ☒ None ☐ Mud ☐ Sludge ☐ Debris ☐ Grease

Infiltration: **None** Pipe Seal Cond: **Unknown**

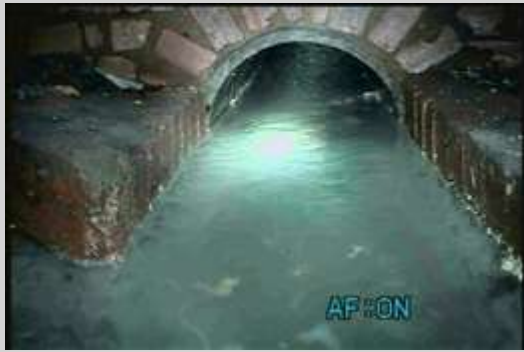
6 O'Clock Inflow

12 in. Circular Gravity Sewer  
Pipe In @ 6 O'Clock

Pipe Material: **Clay** ☐ Pipe Lined

Infiltration: **None** Pipe Seal Cond: **Unknown**
